## Ice Conditions at Cape Hatt, Baffin Island

DAVID F. DICKINS<sup>1</sup>

**ABSTRACT.** The ice environment at Cape Hatt was studied to determine annual variations in ice break-up and freeze-up, which could affect the design, execution and results of the Baffin Island Oil Spill Project. Data from lapse camera stations, field observations and historical charts were used to compare the Cape Hatt ice regime with other arctic sites and to assess the potential for ice interaction with oiled intertidal sediments.

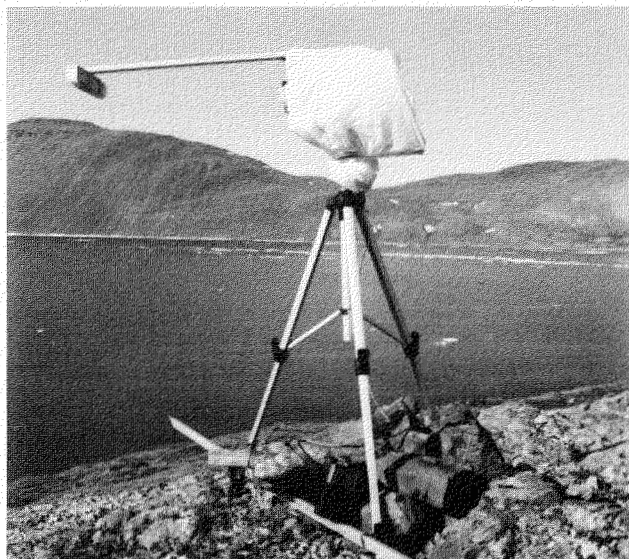
FIG. 1. View showing a typical time-lapse camera installation.

Ice monitoring was carried out by means of remote camera and direct field observations from 22 July to 6 October 1980 and from 1 June to 20 September 1981. Nine time-lapse camera systems were assembled in 1980 specifically for the BIOS Project. These systems used standard Sankyo EM60XL 8-mm movie cameras coupled to custom-fabricated electronic timers set for 4, 8 and 16 min intervals. These timers enabled the cameras to operate for periods of 10, 20 and 40 days respectively between film changes. The cameras employed automatic aperture control and a wide-angle to zoom lens providing up to a 40° field of view. Each camera was equipped with a battery-driven clock visible in the picture frame. Up to three 6-volt alkaline batteries were interconnected to enable unattended operation for up to five weeks, depending on temperature. Protection from the elements was provided by several layers of white plastic bags to minimize daytime heating of the camera body and associated condensation problems as the sun angle decreased later in the day. No external heat source was used. The cameras were mounted on standard photographic tripods heavily ballasted with rocks to provide secure support in strong winds. Figure 1 shows a typical camera installation with the clock extended 70 cm ahead of the lens focal point.

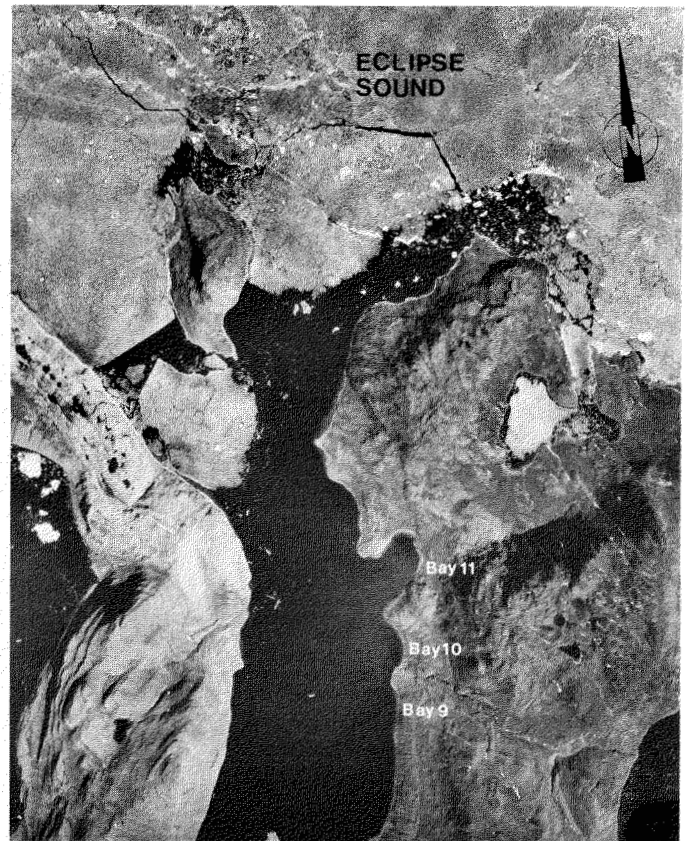
FIG. 2. Aerial photograph showing an example of early break-up around Cape Hatt, 25 July 1958. Photograph provided by National Air Photo Library, Ottawa.

with dates of first ice concentration less than  $\frac{2}{10}$  (aerial coverage) and dates of first new ice formation during the summers preceding, during and following the oil releases. Except for occasional intrusions of older rotting floes from Eclipse Sound, the time span between these two dates represents the approximate period that oil present in the intertidal zone would have been exposed to wave action during those years for which records are available. Table 3 shows that the test bays were exposed to open water for a normal length of time during the summer preceding and during the two summers following the oil releases (compared with the 20-year historical mean). During the 1981 summer, when oil was released, an early break-up and record late freeze-up resulted in an open water period at Cape Hatt three weeks longer than average. That the ice conditions experienced during the summer of 1981 were not unique is evidenced by Figure 2, showing an aerial photograph of Ragged Channel clear of ice on 25 July 1958.

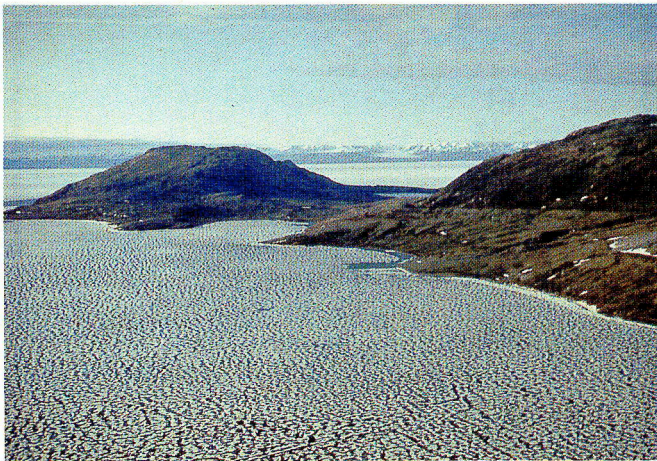
FIG. 3. Ragged Channel completely covered by a rotting ice cover, 23 July 1980.

In 1981, initial fracturing of the ice cover in Pond Inlet and Eclipse Sound was observed in a Landsat image obtained on 13 July. At that time, open water areas were found predominantly along the west shoreline of Navy Board Inlet. By 21 July 1981, open water extended as far south as Eclipse Sound, and Ragged Channel was in an advanced stage of break-up. The previous year saw Ragged Channel still completely ice-covered on 22 July (Fig. 3). Break-up in 1980 proceeded rapidly thereafter, as prevailing northerly winds broke up the rotting ice and drove loose floes to the south of Bay 9 (Fig. 4). In 1981, Ragged Channel was clear of ice by 28 July, approximately one week

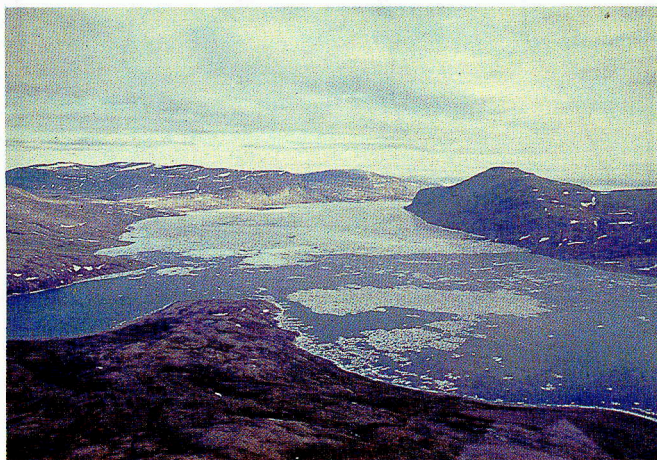
FIG. 4. Ragged Channel half clear of ice on 25 July 1980.

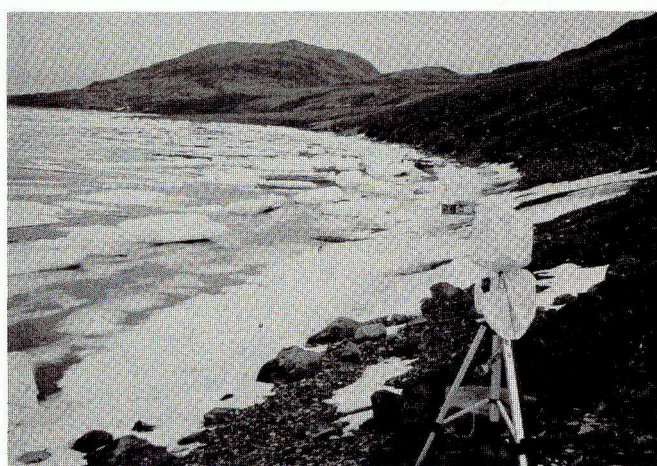
FIG. 5. View of ice along the Bay 9 shore, 27 July 1980.

ahead of 1980. Figures 5 and 6 show contrasting views of the Bay 9 beach from similar camera angles on 27 July 1980 and 29 July 1981 respectively. A time history of ice clearing within Ragged Channel is provided by Figures 7, 8 and 9, showing ice maps derived from helicopter reconnaissance between 22 July and 1 August 1980. The response of ice within the channel to the changing wind directions is evident from the wind direction arrows drawn on each map.

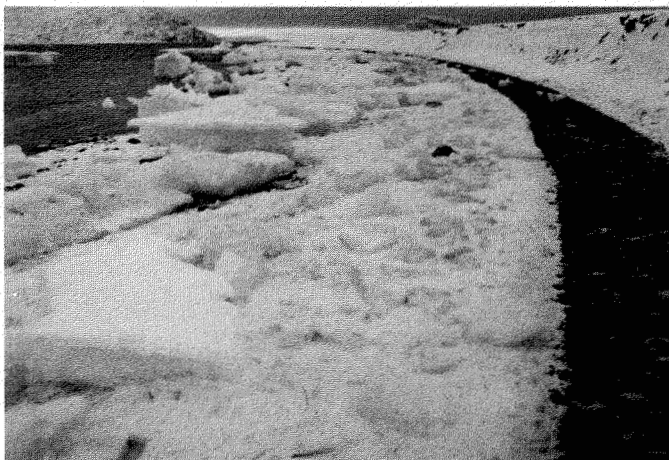
FIG. 10. New ice coating the intertidal zone of Bay 9, 30 September 1980.

The Cape Hatt area remained clear of ice in 1981 until 20 October, a record late freeze-up for the area. Even at this late date, open water was still present in the east end of Eclipse Sound. Figures 10 and 11 show the progression of new ice development within Ragged Channel in 1980, from the first coating of new ice within the intertidal zone on 30 September to grey ice extending halfway across Ragged Channel on 5 October.

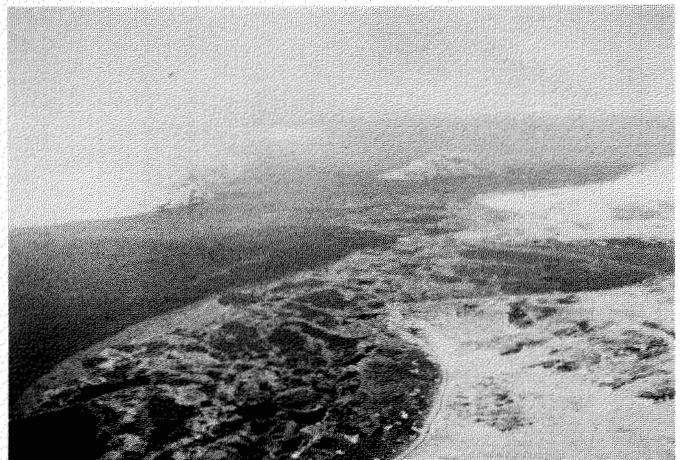
FIG. 11. New ice growing out into Ragged Channel from Bays 10 and 11, 5 October 1980.

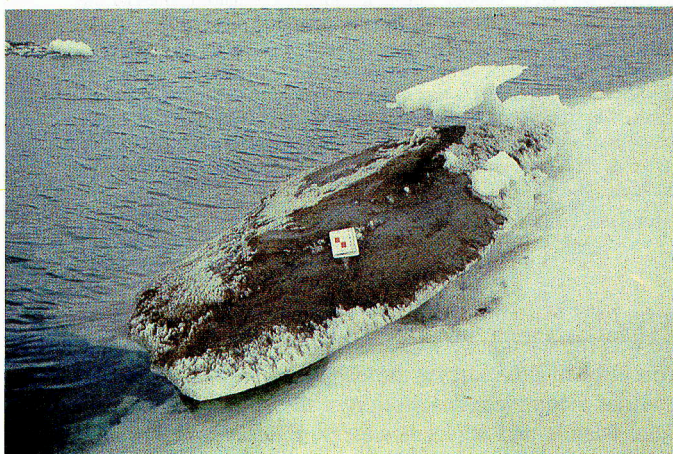
FIG. 13. Sediment-laden ice floe overturned in Bay 10.

where the rotting floes are often concentrated by prevailing northerly winds (Meeres, 1987). In 1980, a limited volume of bottom material was observed being deposited in the intertidal zone by floes that melted after becoming stranded on the beach (Figs. 12-14). Grounded ice tended to be concentrated on beaches having a northerly exposure, in response to the most prevalent wind direction.
