## Tussock Replacement as a Means of Stabilizing Fire Breaks in Tundra Vegetation

WILLIAM A. PATTERSON III<sup>1</sup> and JOHN G. DENNIS<sup>2</sup>

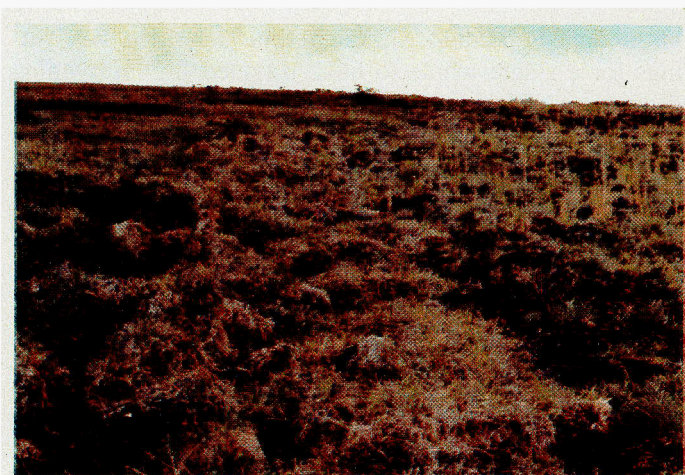
FIG. 1. View upslope of revegetated firebreak (middle), burned area (right), and unburned area (left). Note greater similarity of tussock and dwarf shrub mat vegetation of firebreak to that on the unburned site than to the tussock and *Calamagrostis* vegetation of the burned area.
