## Installation of a Dome Shelter on Mount Logan Yukon Territory

G. HOLDSWORTH

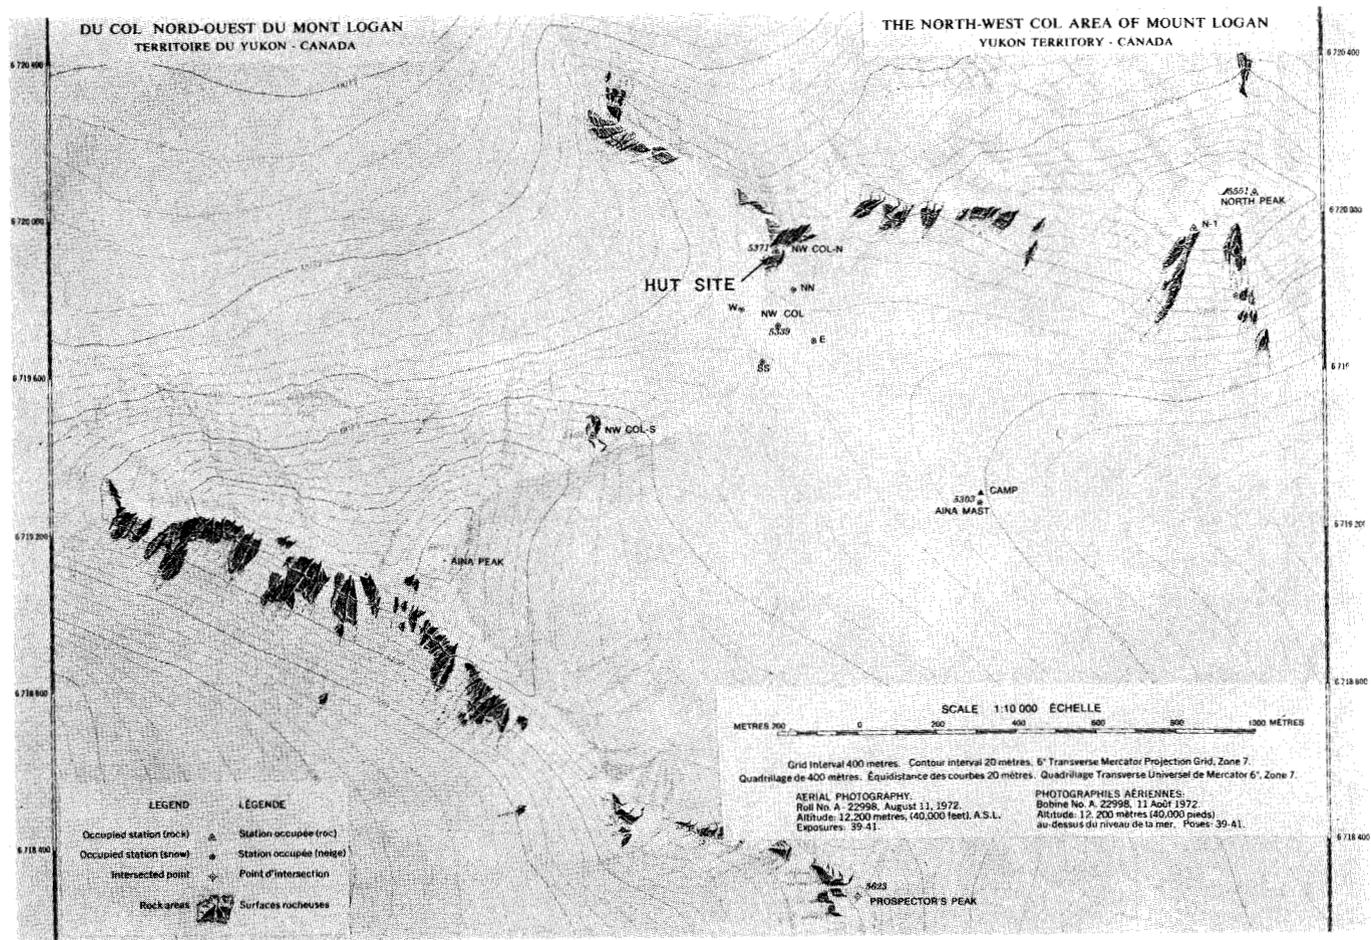
FIG. 1. Map of the NW Col area of Mt. Logan. Hut site is on north side of col where the 5360 m contour crosses the rock.

In 1976 a hut site was found on a solid rock step on the north side of the NW Col 5360 m although some excavation was found to be necessary. This was done by blasting in 1977 by J. Wyss and party, who also completed the foundations, constructed the wooden platform and erected the hut.

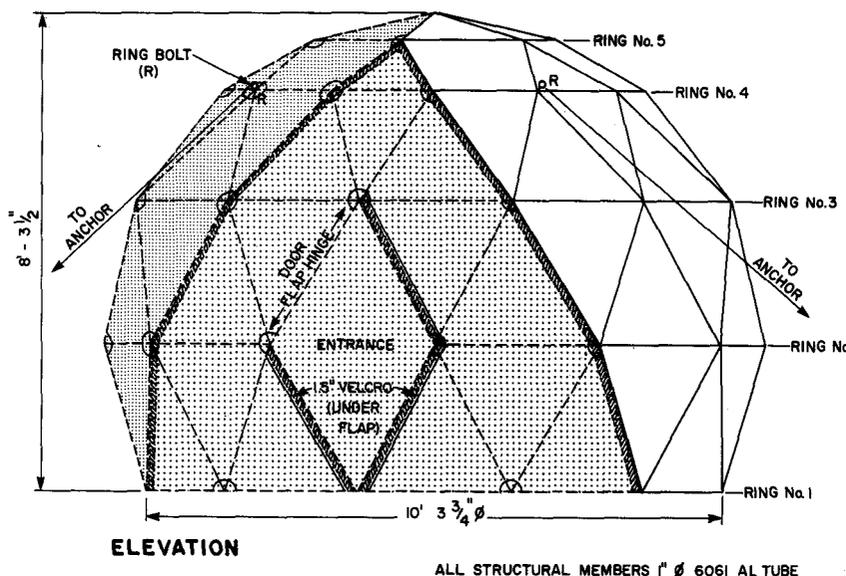
FIG. 2. Plan and elevation of the dome showing cut-away view of main canopy. Outer neoprene nylon canopy is not shown. For details see text. Frame detail courtesy of Triodetic\* Building Products Ltd., Ottawa.

For minimum wind resistance a circular dome design was selected. Because of the restriction of sites, a base diameter of about 11 ft (3.35 m) could not be exceeded. A type of geodesic dome (TRI-O-DOME\*) manufactured by Triodetic\* Building Products Ltd., of Ottawa was selected for the frame. Since neither the standard 10 ft (3.05 m) nor the 16 ft (4.88 m) domes were suitable, a hybrid dome was specially made with a base diameter of 10 ft - 4¾" (3.17 m), a maximum diameter of 11 ft - 6" (3.51 m) and a height of 8 ft - 3½" (2.53 m). (Fig. 2). The structure is composed of 138 aluminum tube sections with lengths ranging from about 2 - 3 ft (0.6 - 1 m). The tubes are 1" (2.54 cm) diameter, 0.065" (1.7 mm) wall thickness, 6061 Aluminum with crimped ends possessing grooves and ridges running at a specified angle to the length of the tube. To form the structure, the ends of the tubes are inserted edgewise into a matching key-way on an annular hub which forms the node or junction of up to six tubes. The tubes are held in place by a nutted stove bolt with capturing washers at either end, except at four equally spaced nodes in the fourth ring where ring bolts were used so that anchoring guy lines could be attached.

A specially designed external canopy was manufactured by Ottawa Awning and Canvas Ltd. It consists of 16 oz neoprene nylon covering the section around the two entrances (ABC in Fig. 2 and the diametrically opposite section). These sections are sewn to heavy duty ripstop nylon which covers the remainder of the dome. A zippered vent (Fig. 2b) occupies a quadrilateral element above the fourth ring. There is also a zippered gauze flap on the inside. The ripstop nylon sections are heavily reinforced at nodal points to prevent wear in the material. Velcro tape is sewn along the junctions between the neoprene nylon surrounding the entrances and the ripstop nylon, on top of which is an outer cover of neoprene nylon identical to the material covering the frame around the two entrances. There are four reinforced slits in the outer cover to allow the ring bolts to pass through and a zippered flap over the vent element. The outer cover can be firmly closed along the velcro strips or rolled up to the level of the fourth ring exposing the corresponding amount of ripstop nylon. These options, as with the use of the vent, are exercised depending on the particular weather conditions existing at the time. An interior frost liner made from light weight cotton canvas was made but not installed because of the usefulness of the exposed tubing for hanging items, especially clothing. Nevertheless, condensation of body moisture on the inside

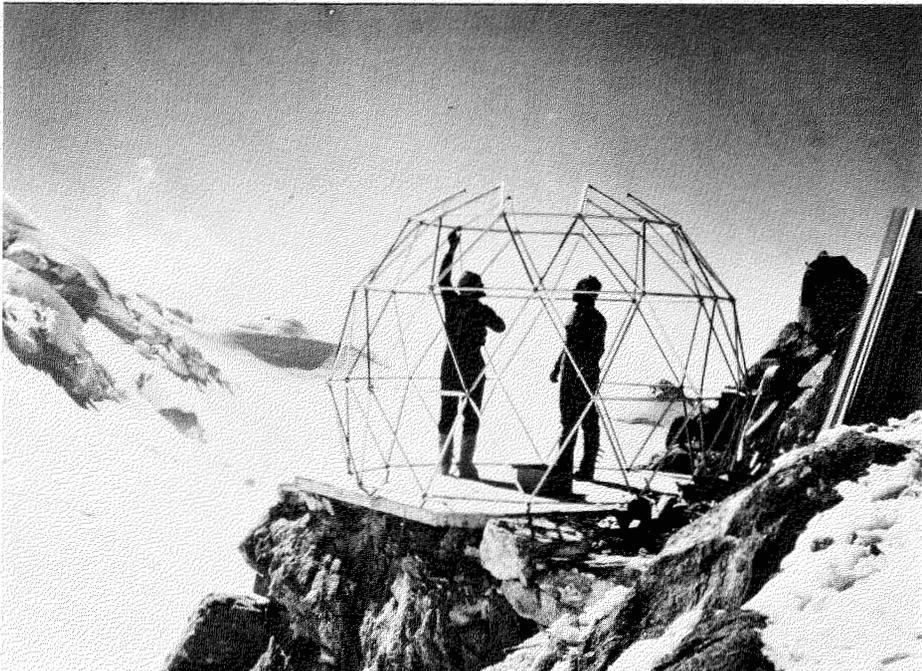
FIG. 3. Partly completed frame showing elemental structure. The NW Col is to the left. (Photo by J. Wyss).

A 10 ft - 6" (3.2 m) square wooden platform was built from nailed 2" x 4" lumber and 1" x 6" tongue and groove planking. The platform rests on firm or excavated rock. Wire cable, 3/16" in diameter, secures the platform to solid rock by means of rockbolts inserted into the bedrock. The TRIODOME\* frame was assembled on the platform from the bottom ring to the apex in a logical manner (Fig. 3). After the main canopy was installed, foam rubber strips were inserted between the bottom ring and the platform to prevent snow drift from entering under the dome. Interior extensions or flaps of the canopy were laid

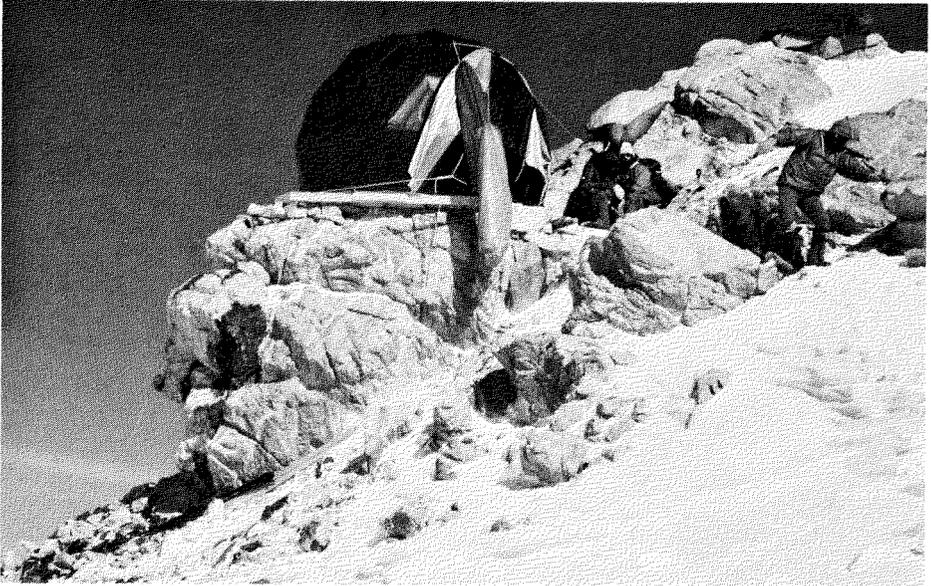
FIG. 4. Completed hut showing part of outer canopy peeled back over inner nylon cover. (G. Holdsworth).

out and a woven fibre nylon tarpaulin was inserted underneath. Staples were then shot through both materials into the floor. The lower ring of the frame was then fixed in place by attaching conduit clamps which were screwed into the floor through the flaps. This sealed the floor. Upon the fitting of the outer canopy, the guy lines were connected to the ring bolts and tightened against the anchors with turnbuckles. This completes the essential steps in the installation of the hut. Figure 4 shows the completed hut.

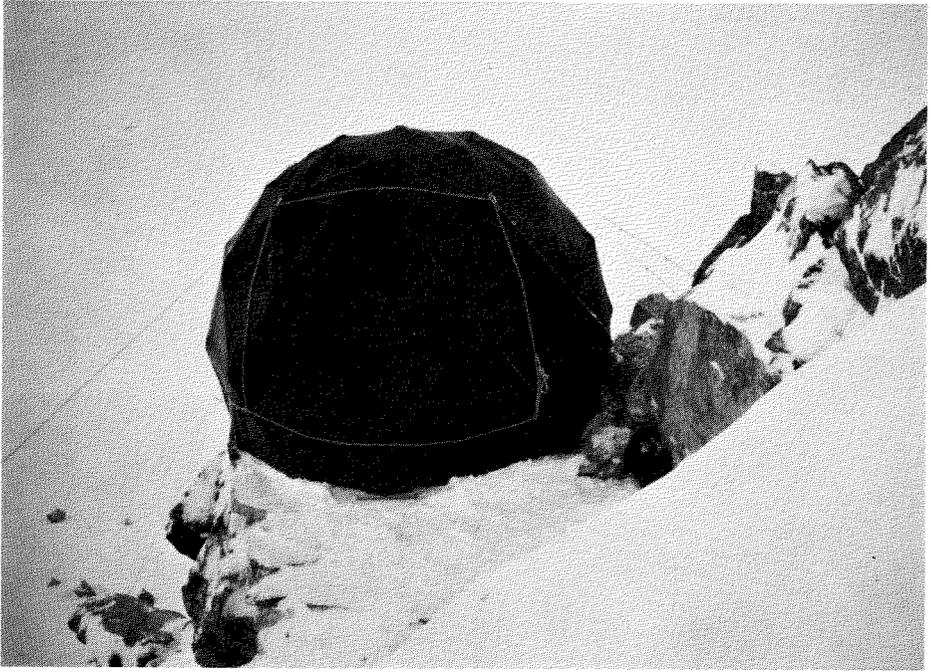
FIG. 5. Hut prepared for winter. (Photo by J. Wyss).

Before leaving the site the construction party tied 11 mm polypropylene rope around the dome, across the Velcro joins and nailed wooden cleats into the platform against the outer edge of the lower ring where the outer canopy fits over it. The hut was left in this condition over the 1977-78 winter (Fig. 5). In July, 1978, the hut was found to be in excellent condition, and was subsequently occupied for three weeks by five persons.

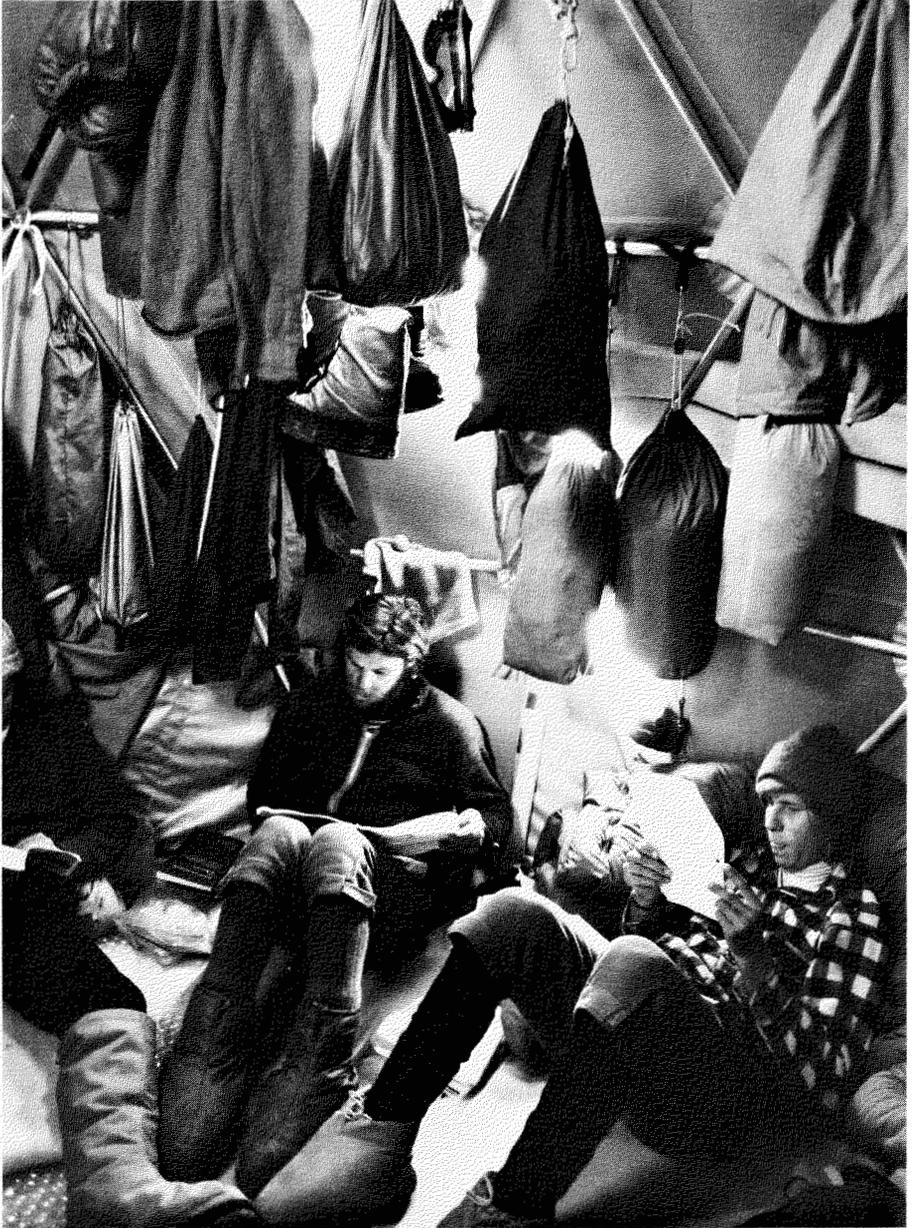
FIG. 6. Part of the interior of the hut showing efficient space utilization. (Photo by G. Holdsworth).

During cold nights with little wind, significant condensation of body moisture would occur, especially in the upper parts of the dome. This could be alleviated by leaving the vent open (or leaving the gauze cover on) and rolling up a substantial part of the outer canopy (on the down wind side), as well as keeping one of the entrances partly open. Otherwise, as the dome absorbed solar radiation and the interior heated up, water droplets would form, causing a continual drip onto the occupants. Frequent sponging was one solution but a frost liner would be more satisfactory. The TRI-O-DOME\* (TRIODETIC\* and TRI-O-DOME\* are registered trade marks of Triodetic Structures Ltd.) offers comfortable space for four average sized persons. A partial view of the interior is shown in Figure 6.
